CASE REPORT

Intra-operative radiological diagnosis of a tip roll-over electrode array displacement using fluoroscopy, when electrophysiological testing is normal: the importance of both techniques in cochlear implant surgery[☆]

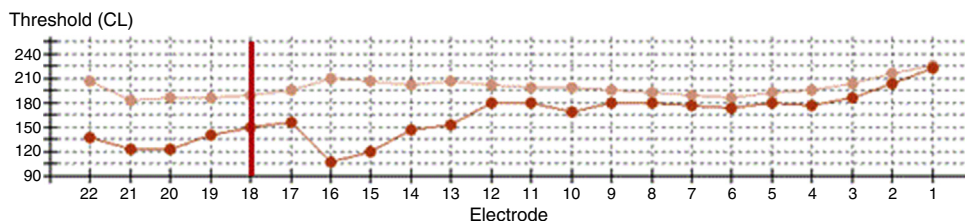
Figure 1 Intraoperative neural response telemetry: the first measure (tip rollover) is represented by the beige line and the second measure (reinsertion) by an orange line. The vertical red line marks the limit of the distal tip roll-over (e18–e22).

The patient was diagnosed with single-side deafness and a cochlear implant was advised in the right ear. Surgery was performed via posterior tympanotomy, an extended round window cochleostomy performed and a CI532 perimodiolar array was inserted (Cochlear®). Intraoperative neural response telemetry (NRT) (Fig. 1) and impedance (Fig. 2) were first used to evaluate appropriate function using the CR220 Data viewer Cochlear® and values in normal ranges were obtained. Then an intraoperative fluoroscopy was performed using an Arcadis® Orbic 3D C-arm, and even though the array was apparently well-inserted through the extended round window cochleostomy, the tip presented a rollover in its distal part, corresponding to the last five electrodes (e18–e22). The array was then removed and was repositioned in the insertor and reinserted for a second time. NRT and impedance were in normal ranges again, but when compared to the first measurement this time the impedance levels and the NRT thresholds had lower values. Correct insertion and shape of the cochlear implant array was visualized by intraoperative fluoroscopy (Fig. 3).

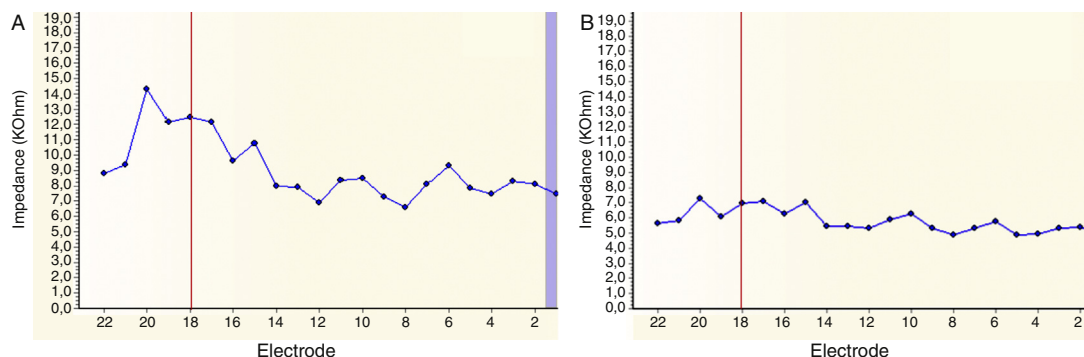
Figure 2 Intraoperative impedance. (A) The first measure (tip rollover); (B) second measure (reinsertion). The vertical red line marks the limit of the distal tip rollover (e18–e22).

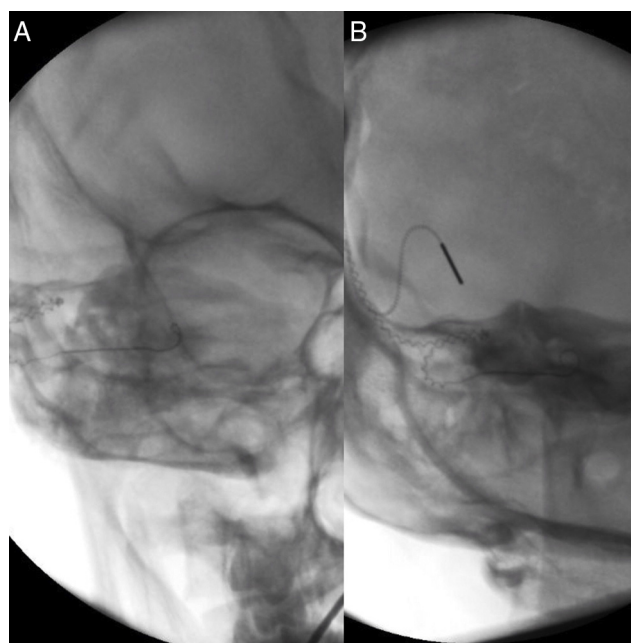
Figure 3 (A) Fluoroscopy after first insertion (tip rollover); (B) fluoroscopy after second insertion (correct placement).

to insertion. In our case we think that the cause was due an improper insertion of this new electrode. This particular electrode array is charged in a seal, following which it was manipulated by the "advance sheath", and then the electrode was inserted in the cochlea bended since the beginning. Fortunately, the design of this device allowed us its reutilization and replacement with better impedance levels and the NRT thresholds. Nevertheless reinsertion is more traumatic to intracochlear structures.
