A STUDY OF THE ANCIENT MORTARS IN THE NORTH TOWER OF

PAMPLONA'S SAN CERNIN CHURCH

A STUDY OF THE ANCIENT MORTARS IN THE NORTH TOWER OF PAMPLONA'S SAN CERNIN CHURCH

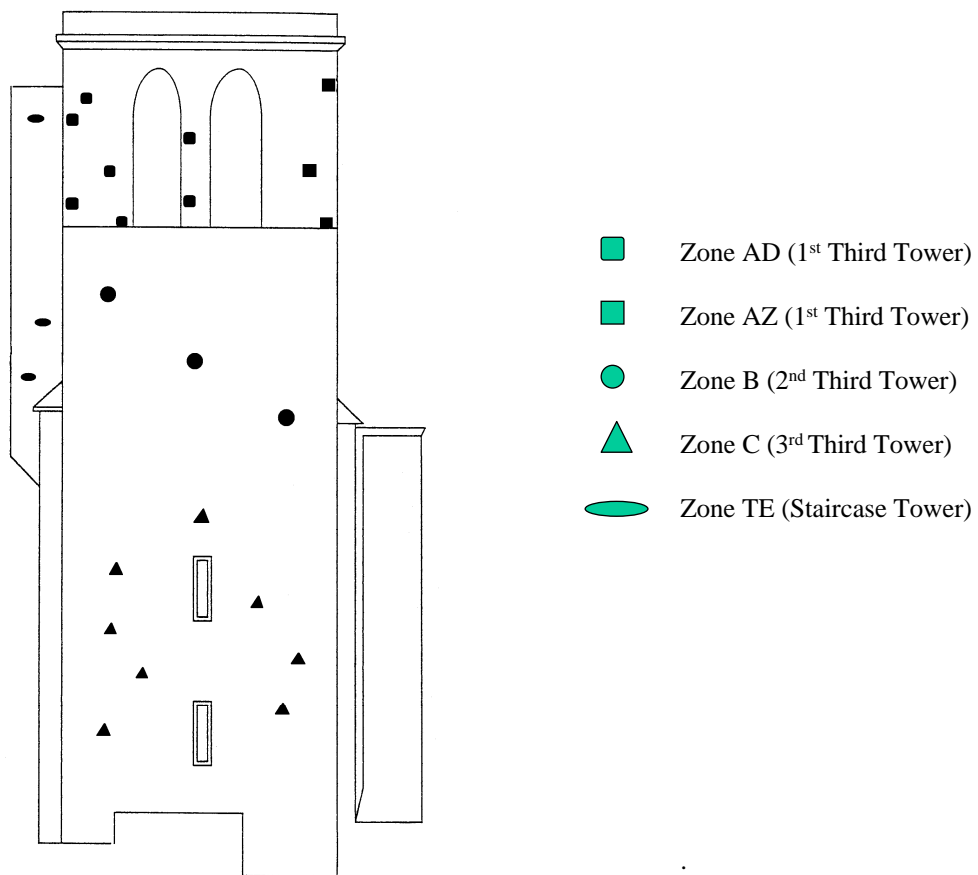
Figure 1. Areas of sampling in the North Tower of San Cernin Church

A total of 24 mortar samples were studied, belonging to the various thirds of the tower and to the adjoining exteriorly accessed staircase (Fig. 1). At least three samples of each architectural zone were taken to assure representative results.

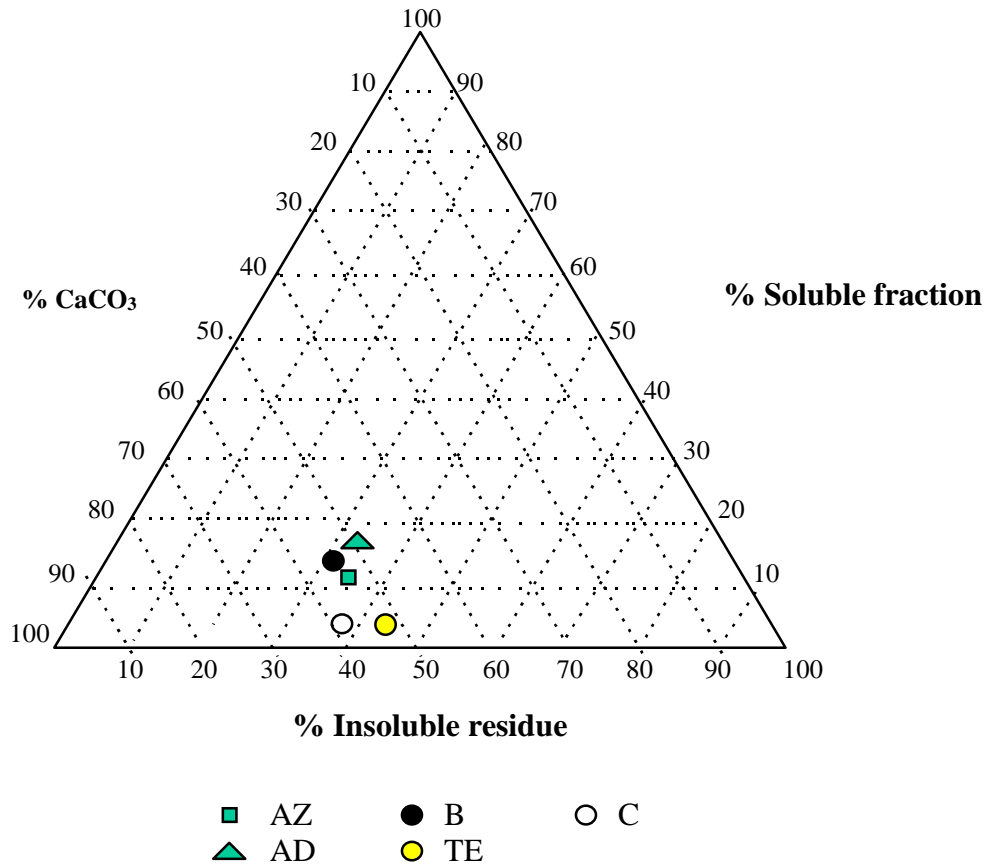
Figure 2. Triangular Diagram. Average Values

The zone TE is clearly different to the three previous zones, as zone C. This situation can be observed in the representation of the average values of the samples of each zone. The following figure represent the grouping of the average values of $CaCO_3$, insoluble residue and soluble fraction analysis of the diverse architectural zones (Fig. 2).

The mean values of the relationship IR/SF obtained for each architectural zone studied in the tower of San Cernin are collected in Table 3. This parameter also makes possible discrimination among the zones previously indicated: the zones TE and C are differentiated between themselves and the others.

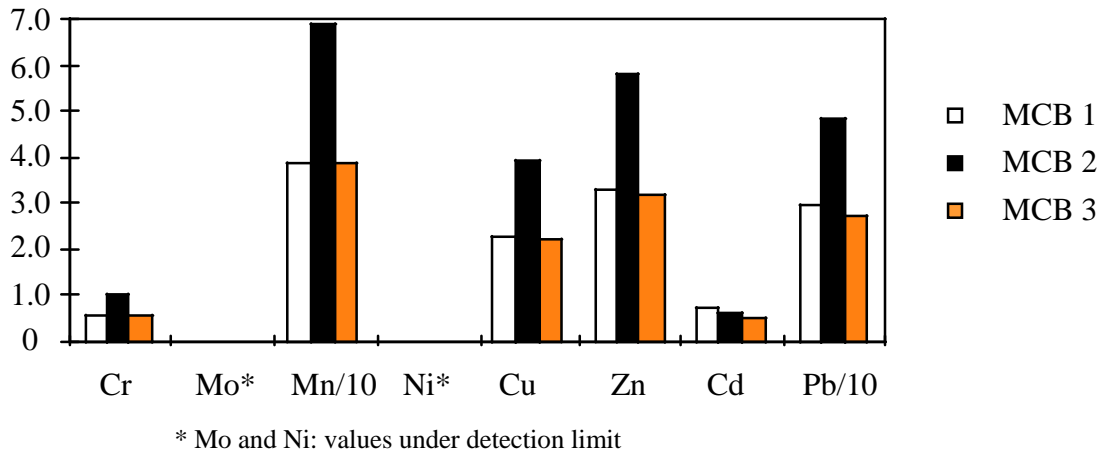
Figure 3. Diagrams in trace elements in representative mortars (μg trace element/g dry sample)

Trace Elements: the chemical nature of the trace elements and their relative concentrations indicate the geological history of the material, in function of the parameters that have conditioned them [12,13]. Figure 3 shows the graphs of trace metals.

The critical study of these graphs indicates that there are not large differences in the composition of the trace metals analyzed among the mortars of the three studied classes. Therefore, it is probable that the materials used proceed from the same quarry. This is logical if one considers the size of the tower of the Church of San Cernin which was built, furthermore, in a continuous form.

The classes MCB1 and MCB3 have almost identical micro-chemical composition, their raw material proceeds from the same quarry and zone. This also is adjusted to the distribution found for the classes of mortars within the tower of the Church of San Cernin (MCB1, superior and center thirds of the tower; MCB3 inferior third). Air pollution could be the responsible for the high contents of lead.

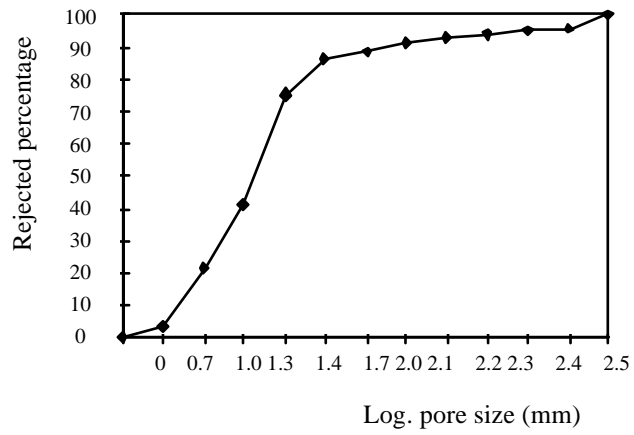
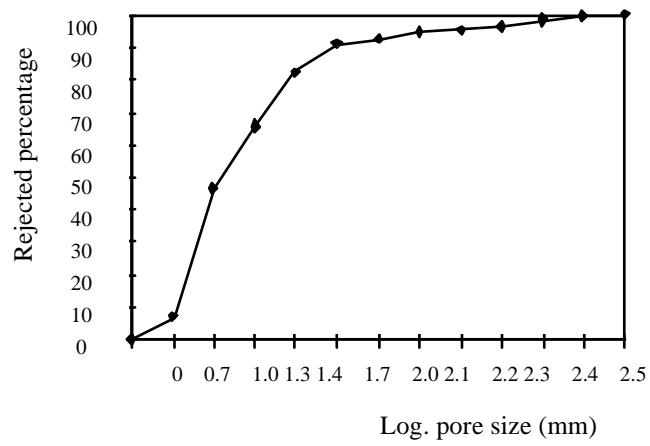
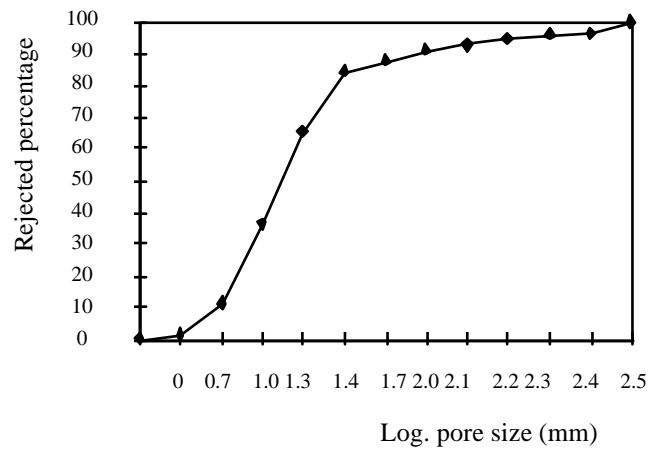
The distribution characteristics of the grain size of the arid through a granulometric study have also been undertaken. They have configured the following cumulative granulometric distribution (Fig. 4-6).

It is observed that the clayey fraction (< 0.1 mm) is very high in MCB2 (46%), in comparison with MCB1 and MCB3. The fine sand fraction (0.20-0.50 mm) turns out to be, in MCB1 and MCB3 (65.06 and 73.03%, respectively) in percentage terms, the most important fraction. In the intermediate sands (1-1.6 mm), large differences are not found, although MCB2 presents the smaller rejected percentages (4.28%). In the bulk sands fraction (2-4 mm) MCB1 and MCB3 are around 7% of rejection and 4.5% for MCB2, being, in any event, percentages not very important.

Via the value of the median (Table 8) we find that the studied mortars have in their majority fine sand composition and especially the class MCB2. The S_o (the quotient between the 3rd and 1st quartile expressed in mm) shows a sand well selected (under< 2.5) [15] for the classes MCB1 and MCB3, acceptable for their employment in mortars, while the aggregate used in MCB2 does not show an adequate scale in the grain sizes.

It indicates that there is a manifest similarity among the aggregate of the classes MCB1 and MCB3 that permits the hypothesis that their origin was identical.
